REMEDIAL ROOF REFURBISHMENT NORTH SYDNEY

MAY 2019

Project Brief:

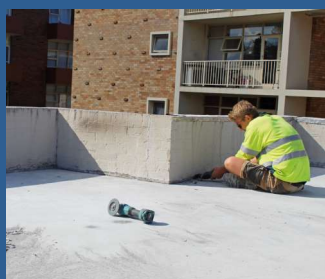
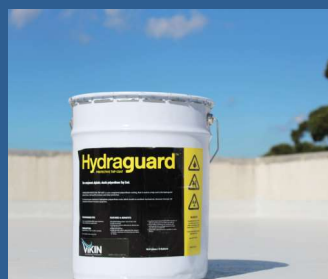
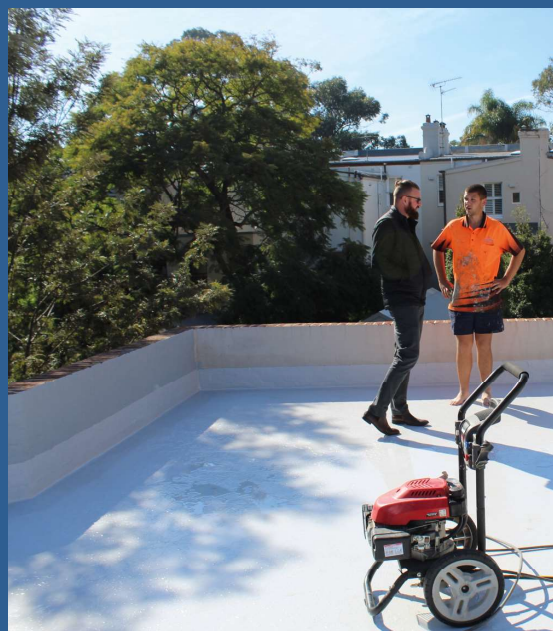
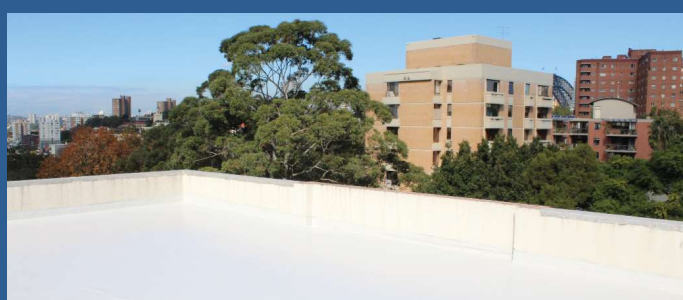
The client contacted VIKIN after many years of waterproofing failures and bandage solutions to an exposed concrete roof space.

After inspection, it was confirmed that the existing failing fibre reinforced membrane be removed by grinding. Once done so, the cracks in the slab were treated and VIKIN Epoxy Primer / VIKINGuard Base / Hydraguard UV system was applied - bankrolling non slip aggregate so the space could accommodate foot traffic.

VIKIN Epoxy Primer
 VIKINGuard Base
 Hydraguard UV system

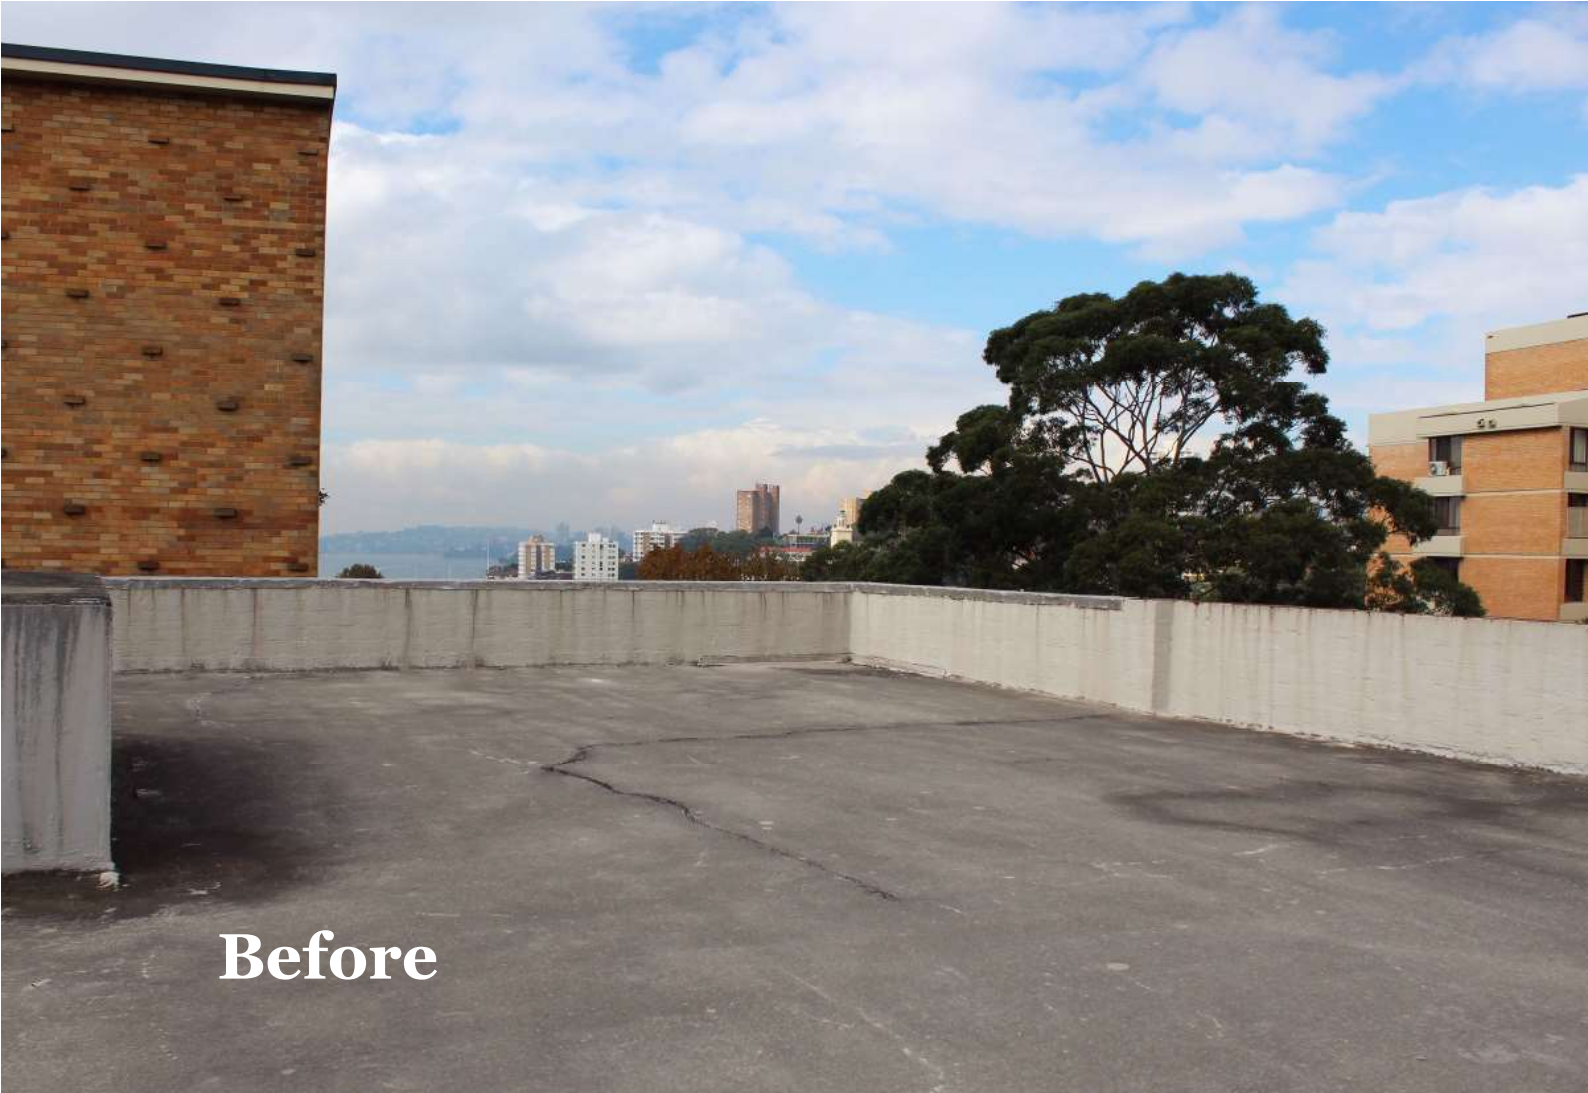
Before

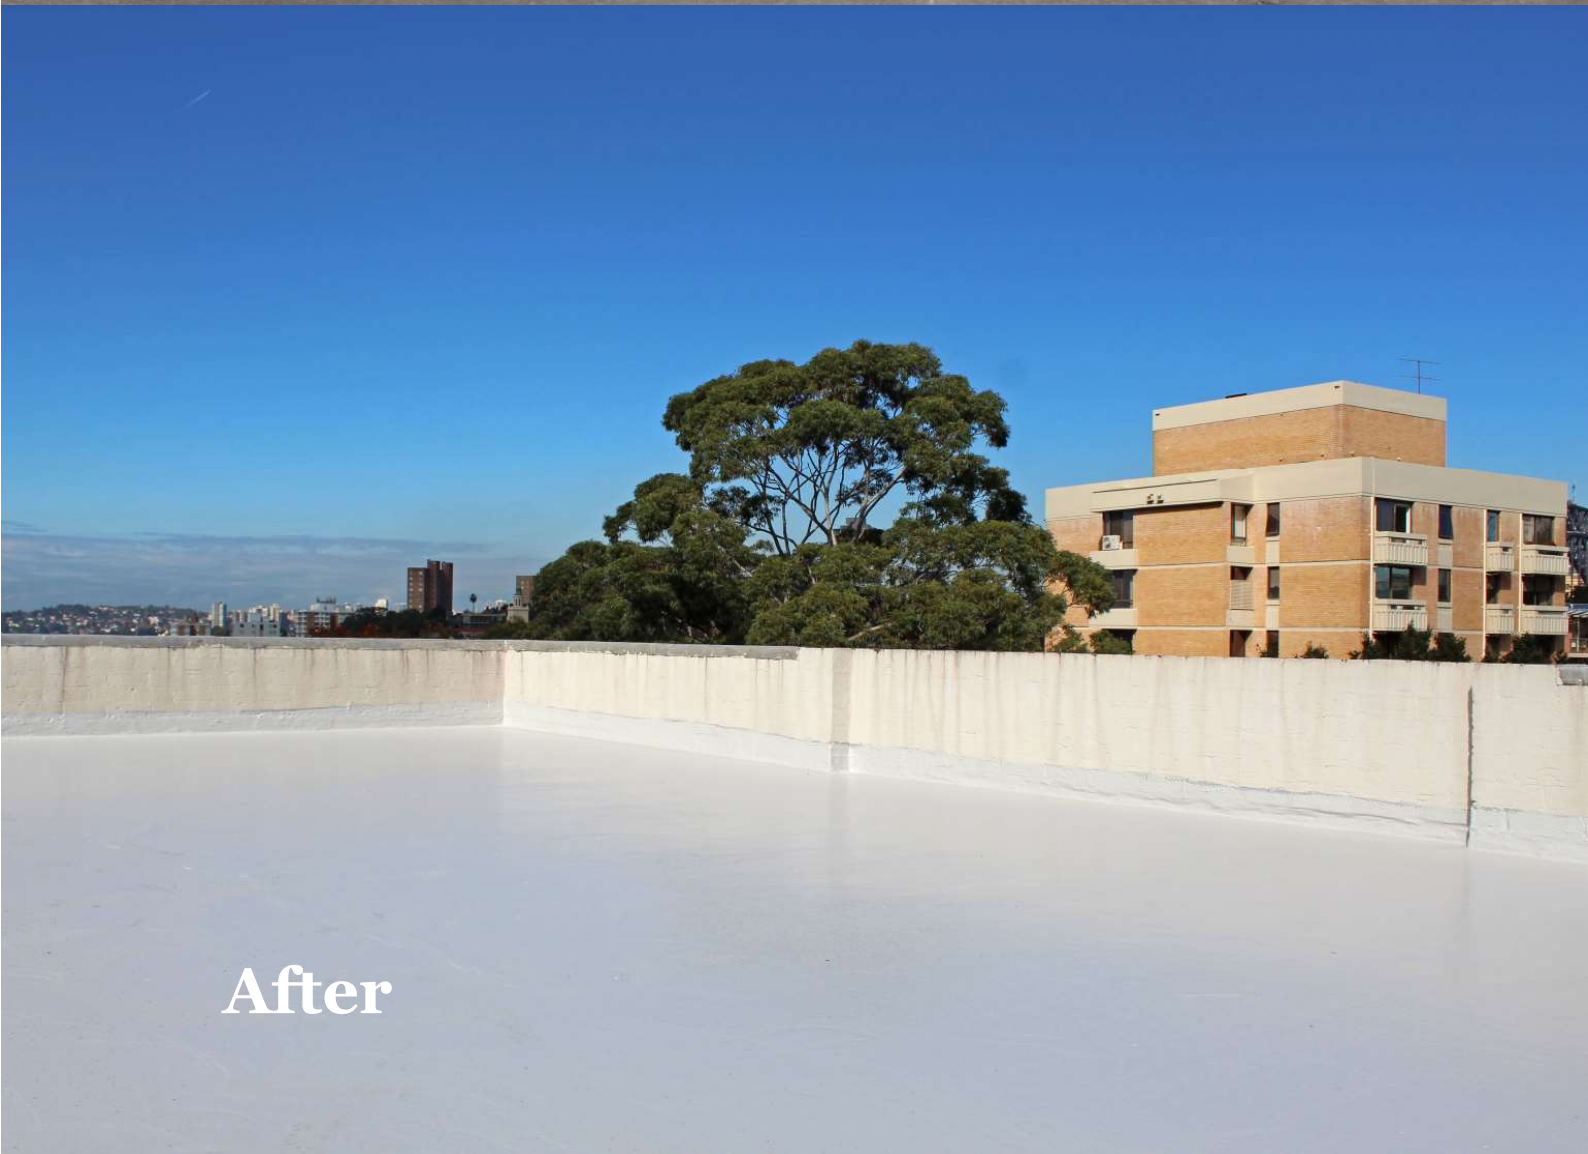
After
